## Rivet Rash – The Itch That Won’t Heal

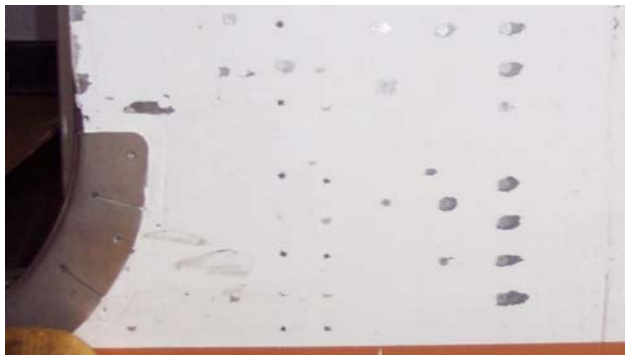
“Rivet rash” refers to selective loss of paint from aluminum rivet heads on in-service aircraft, as shown in Figures 1 and 2 and 3. Airlines are dissatisfied with this condition since it greatly detracts from the airplane’s decorative paint appearance in areas most visible to the passengers, namely the 41-section (nose) and entry doors. In addition, rivets can “rash” within six months of delivery giving the airplane a prematurely older appearance.

Figure 1. Rivet rash adjacent to forward airstair door

(MR&D) and Phantom Works. The team also included the rivet vendor, Allfast Fastening Systems, Inc. Using a combination of performance and analytical testing, the team found the failure locus in the rivet rash area to be between the rivets’ chromate conversion coating and the decorative paint’s primer.

To pose a minimal disruption to the current rivet finishing line, to enable use of the commercially available AC-131 formulation, and to meet schedule deadlines, the process of applying the sol-gel over the clear MIL-C-5541 was selected. This process also allowed the paint hangars to continue without any change in operational procedures.

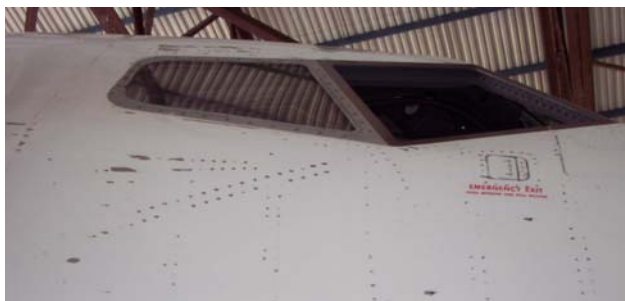
Figure 2. Rivet rash on fuselage structure

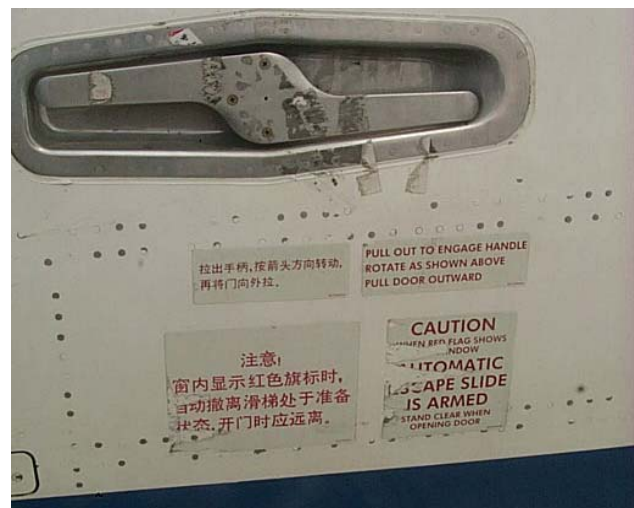
Figure 3. Rivet rash around door

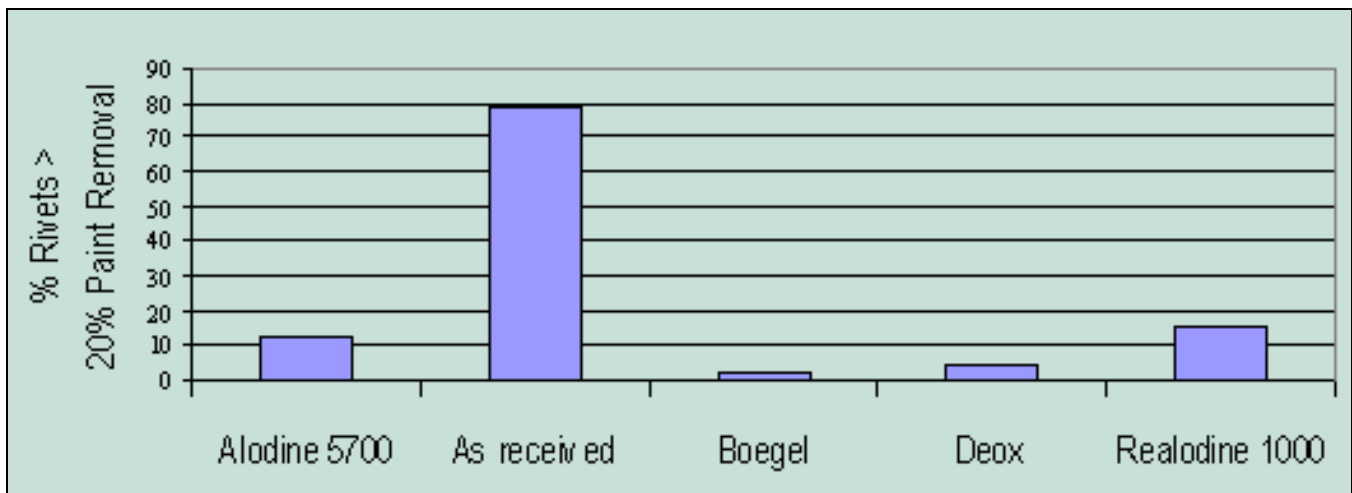
Fig 5. Initial Rivet Coating Adhesion Screening Testing

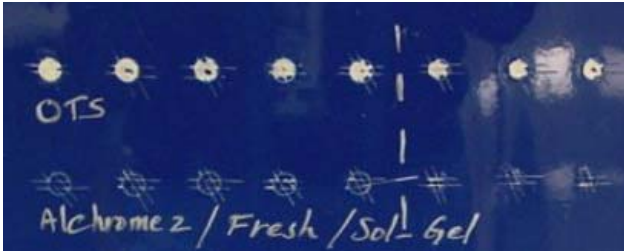
Scribed adhesion testing showed vastly improved adhesion under a variety of exposure and aging conditions. A typical paint adhesion test is shown below, in Figure 6, where complete loss of paint occurs from the heads of the baseline off-the-shelf

chromate conversion coated rivets, whereas the sol-gel treated rivets show no paint removal at all in the scribed area.

Figure 6. Rivet adhesion testing comparing off-the-shelf (OTS) rivets (top) to sol-gel coated rivets (bottom)

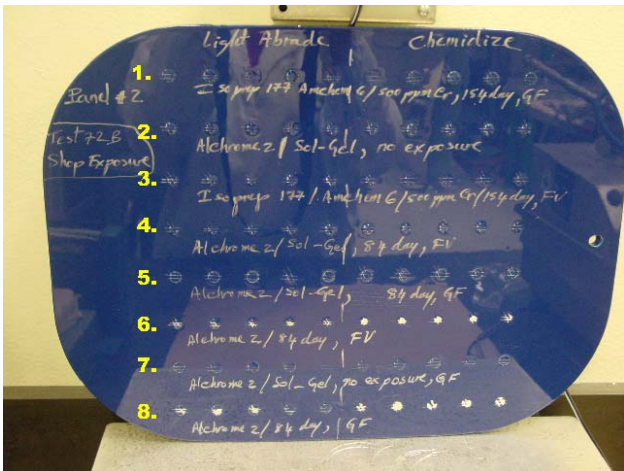
Adhesion tests were conducted using both types of deoxidation methods (Figure 7.)

Figure 7. Window cutout panel showing light abrade (right) and Chemidize (left) test rivets.

1. GF rivet, chromated sol-gel, 154 day shop exposure.
2. FV rivet, sol-gel over chromate conversion coating, no shop exposure.
3. FV rivet, chromated sol-gel, 154 day shop exposure.
4. FV rivet, sol-gel over chromate conversion coating, 84 day shop exposure.
5. GF rivet, sol-gel over chromate conversion coating, 84 day shop exposure.
6. FV rivet, chromate conversion coating, no sol-gel, 84 day shop exposure.
7. GF rivet, sol-gel over chromate conversion coating, no shop exposure.
8. GF rivet, chromate conversion coating, no sol-gel, 84 day shop exposure.

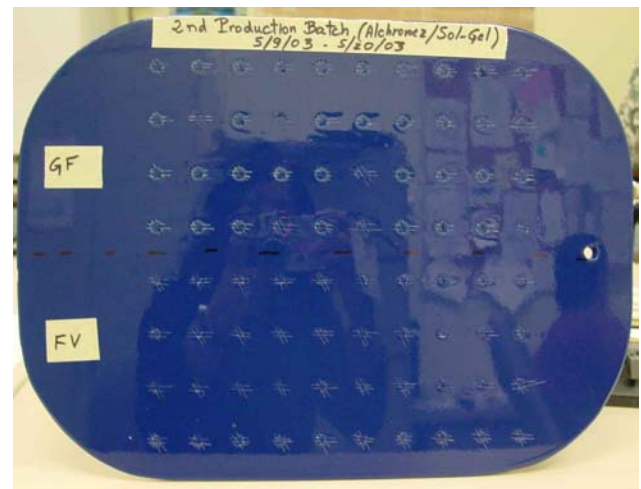
Customer-delivered aircraft will be monitored subsequent to the new rivet installation to determine the level of effectiveness of the new coatings. Spot monitoring of vendor-supplied rivets is also being carried out to confirm the robustness of the process. (Figure 8.)

Figure 8. Window cutout panel showing test rivets from the second production batch of sol-gel coated rivets.
